LOCATION MAP AND TABLE OF

FIRST FLOOR **BULK SAMPLE LOCATIONS AND ASBESTOS** CONTAINING **MATERIALS**

ASBESTOS PRE-DEMOLITION SURVEY FOR BEECH-NUT NUTRITION CORPORATION

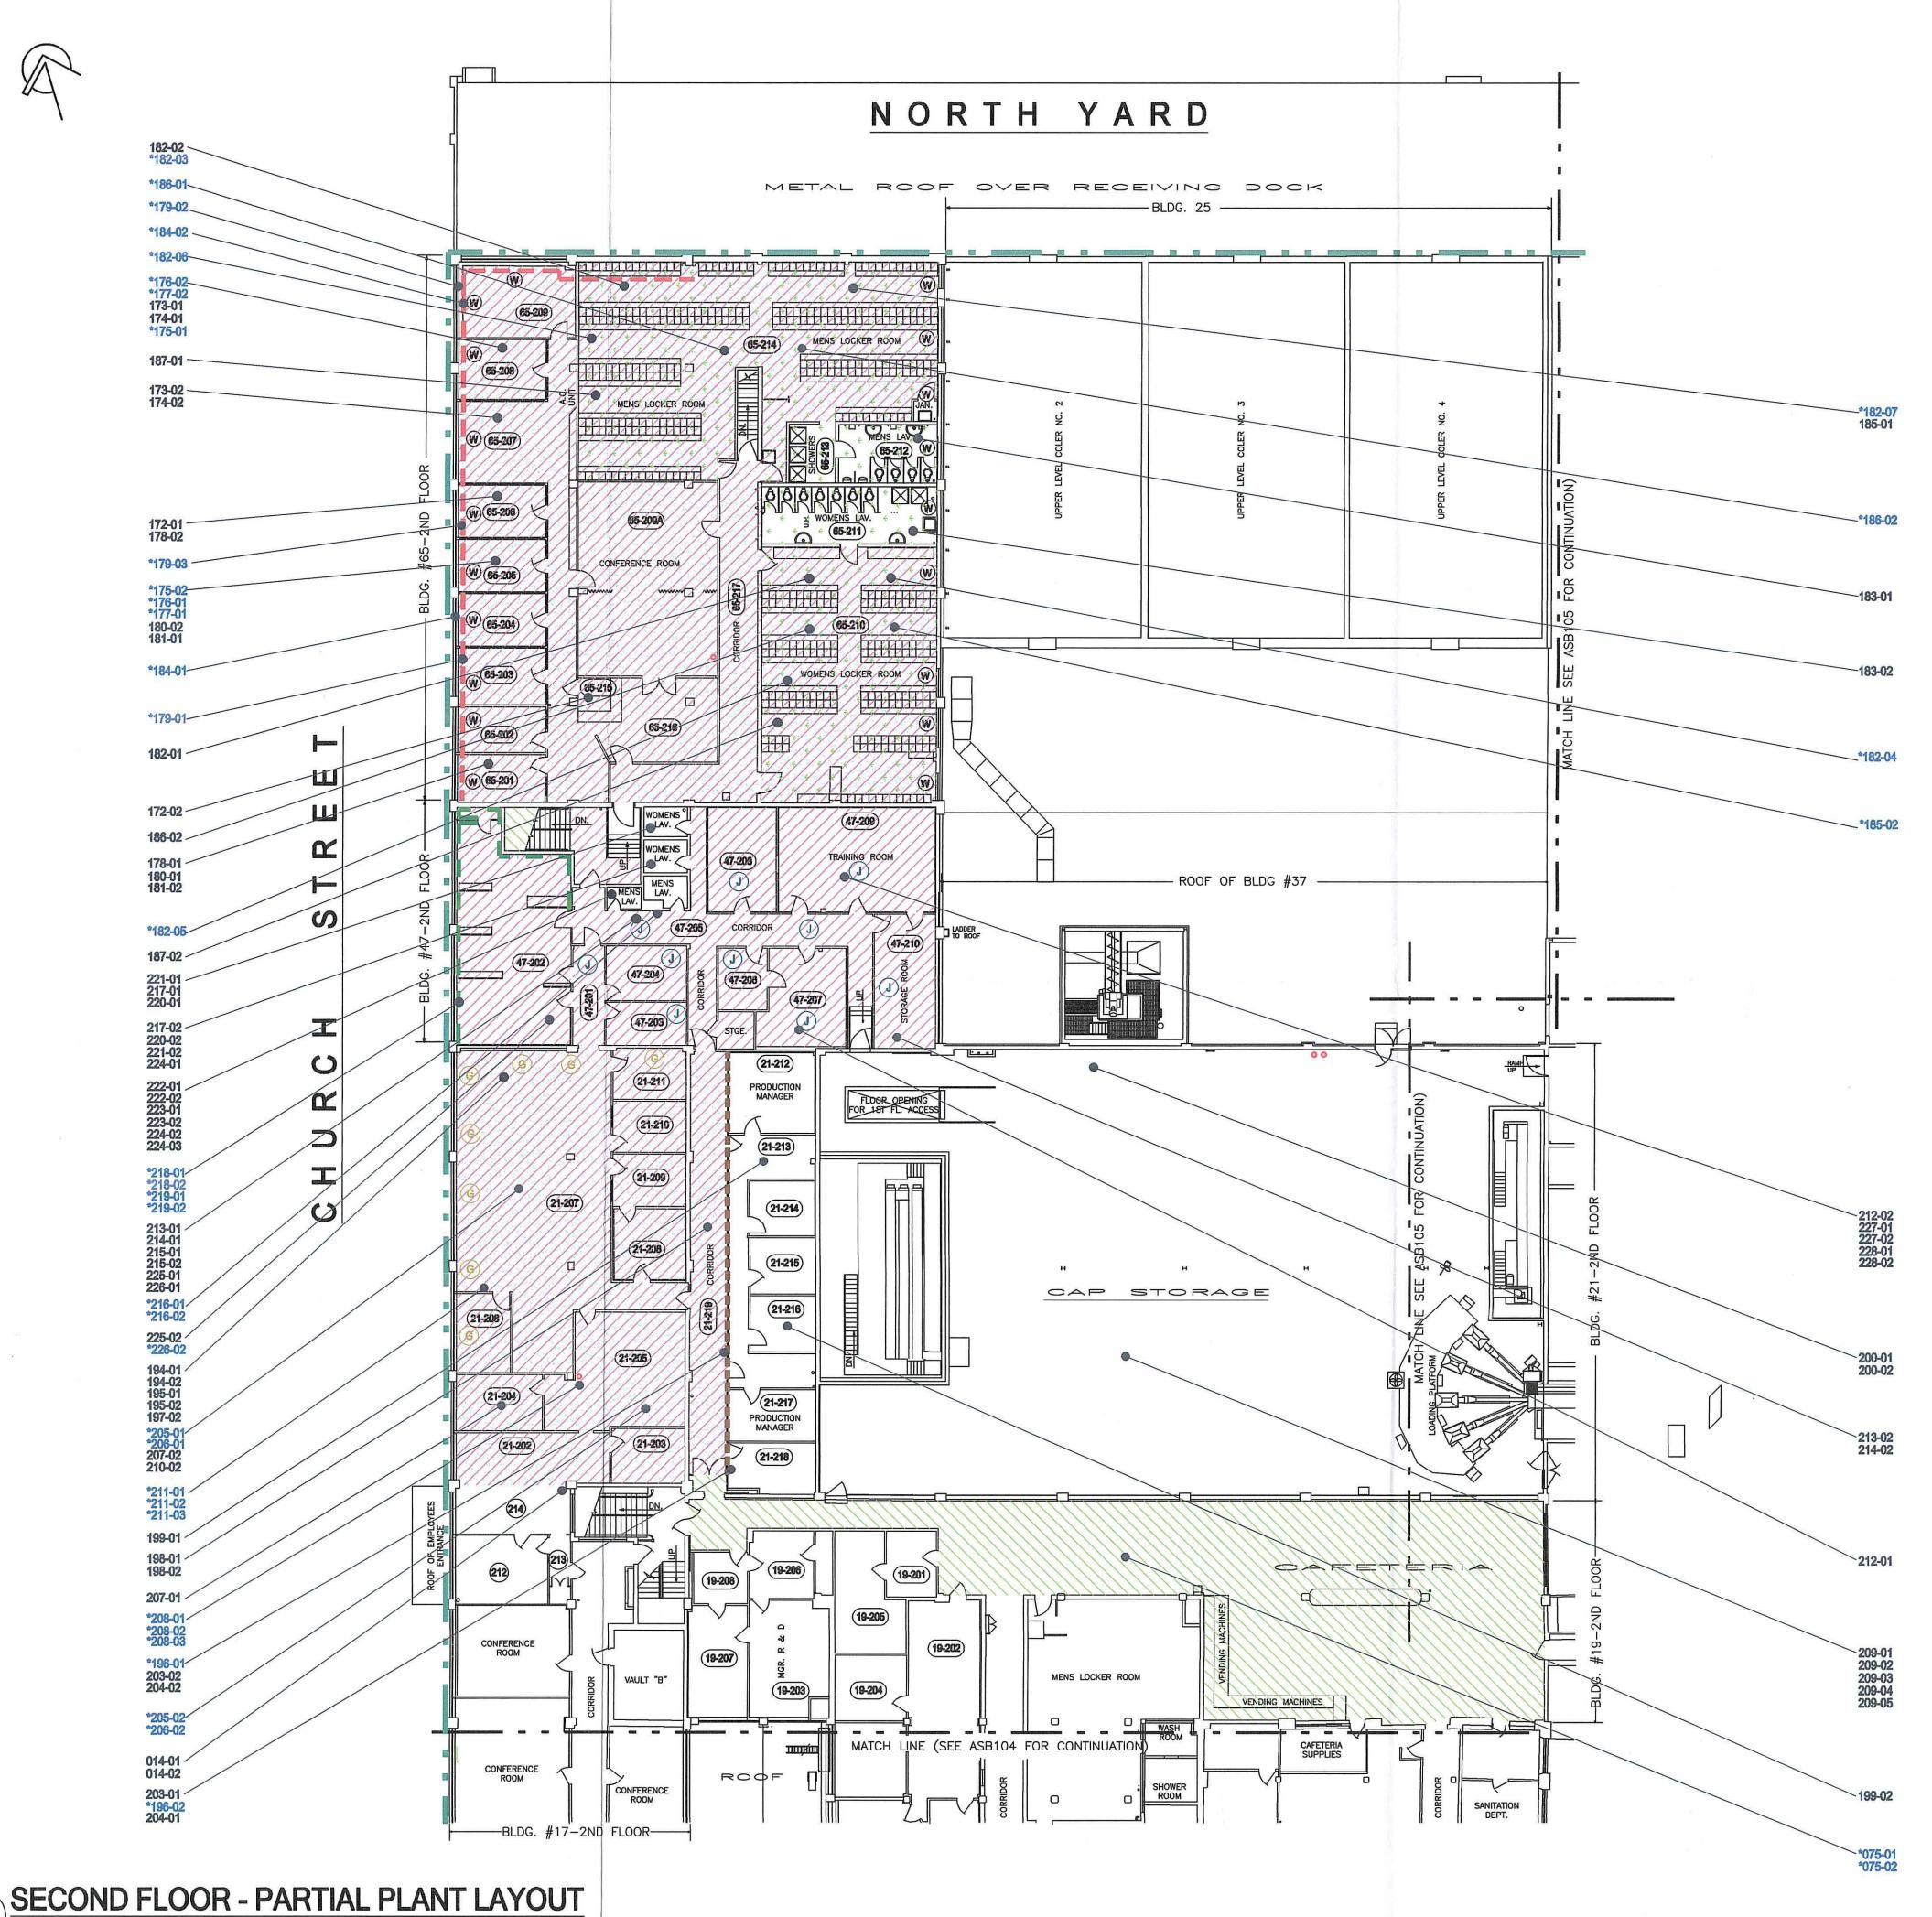
ASB105

SECOND FLOOR
BULK SAMPLE
LOCATIONS AND
ASBESTOS
CONTAINING
MATERIALS

LEGEND	QTY.
XXXXXX	SAMPLE NUMBER	N/A
0	SAMPLE LOCATION NUMBER	N/A
XXXXXX	POSITIVE SAMPLE NUMBER	N/A
	EXTERIOR WHITE PAINT	SEE NOTE 1
W	WINDOW GLAZING	SEE NOTE 1
///	9x9 FLOOR TILE - GREEN, BROWN, WHITE, GREY	15,300 S.F.
	9x9 FLOOR TILE MASTIC	11,900 S.F.
	12x12 FLOOR TILE - GREEN, BROWN, WHITE, RED, BLACK, TAN	3,700 S.F.
	THERMAL SYSTEM INSULATION LARGE AND SMALL DIAMETER	140 L.F.
0	PIPE FITTINGS	2 EACH
88086	TRANSITE WALL PANEL	100 S.F.
	4" BLACK COVE BASE AND MASTIC	160 L.F.
	WHITE CEILING PAINT	4,500 S.F.
G	GREEN WALL PAINT	300 S.F.
(J)	JOINT COMPOUND ON SHEETROCK WALLS	1,300 S.F.
